TECHNICAL REPORT REMR-CO-3

**CASE HISTORIES OF CORPS BREAKWATER
AND JETTY STRUCTURES**

SOUTH ATLANTIC DIVISION

Francis E. Sargent

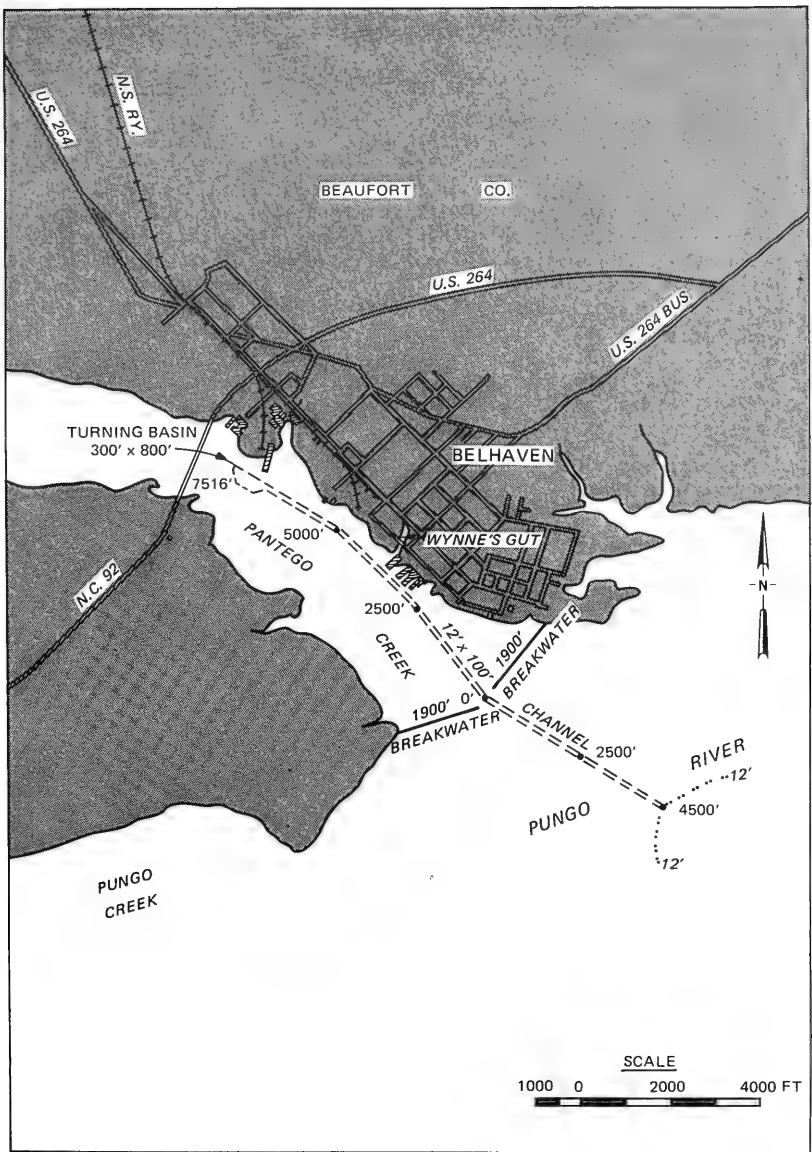
Figure 5. Belhaven Harbor, North Carolina

1982	<p>Visual examination showed that approximately three dozen timbers were missing over the length of the breakwaters. Also, a few pilings were missing. It was thought that the damage resulted from the impact of transient barges tied to the structure.</p>
1985	<p>The structure does not provide its intended wave protection, but at present there are no plans for improvement.</p>

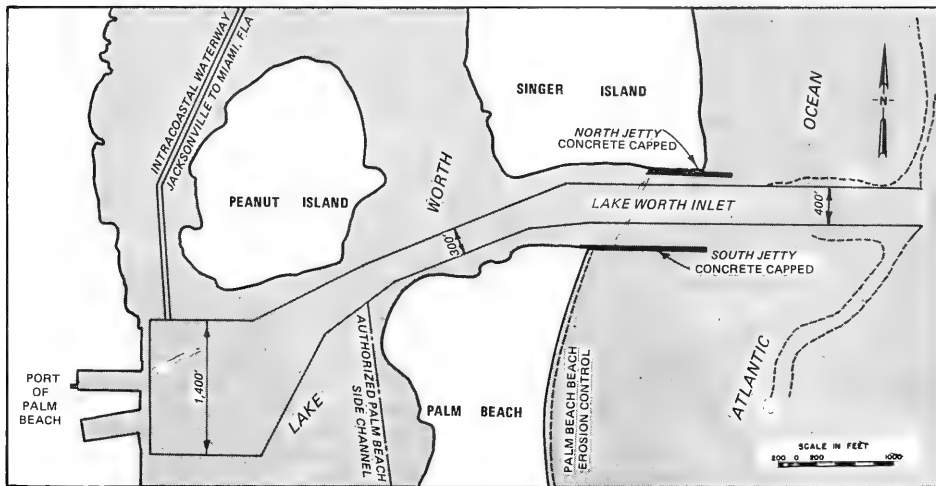
Figure 33. Palm Beach Harbor, Florida

1945	A 40-ft section of the concrete cap on the south jetty approximately 420 ft from the shoreward end had settled about 4 in., had longitudinal cracks, and was acting as a beam. These occurrences were brought on by tidal scour through, and settlement of, the underlying armor stone. The cause of the problem was thought to result from the lack of additional armor stone placed in this and adjacent sections of the old jetty during the 1934-38 rehabilitation. The north jetty was in good condition, and its only problem was its ineffectiveness as a barrier to tidally-induced sand motion under the structure. This problem was evidenced in the original jetties and

Date(s)	Construction and Rehabilitation History
1945 (Cont)	was one reason for the 1934-38 rehabilitation. Examination of the jetty heads showed that the north jetty, with its asphaltic concrete, was in good condition but that the south jetty, without the asphaltic concrete, had deteriorated and needed 1,000 to 1,500 tons of 8- to 10-ton stone to restore the original design.
1948- 1949	The south jetty was inspected and surveyed. The outer 500 ft of the cap had settled 1 to 6 in. because of displacement of the underlying armor stone (occurred during the hurricane of 11-19 September 1947). On the landward half of the cap were a number of holes resulting from serious loss of armor stone from wave action. Near the shoreward end of the cap, a 40-ft section was cracked badly. By this time, the nonasphalted head of the jetty had largely disappeared. There was also some deterioration along a 170-ft section at the jetty cap revetment interface. Undermining of stone because of wave action and currents (scouring) was felt to be the major cause of deterioration. The channel was deepened to -27 ft mlw.

1950	In January 1950 repairs to the north jetty consisted of (a) placing a filter blanket of 1/4- to 6-in. stone along 200 ft of its shore-side landward junction (to impede sand motion) and (b) placing existing and additional 500- to 2,000-lb armor stone at the revetment/jetty cap interface (30-ft section). In March 1950 repair of the south jetty consisted of placing 2- to 10-ton armor stone as needed. Total cost of the repairs to the south jetty (26,000 tons of stone placed) and revetment was \$227,000. (The jetty portion was roughly 90 percent of the total.) In August 1950 an underwater survey of the asphalt-filled north jetty showed some deterioration on the channel side; otherwise, it continued to function properly.
1955	Repairs were made to the north jetty from the existing shoreline to the landward end of the concrete cap (500 ft). A total of 1,300 tons of 6-ton minimum capstone was placed on the channel side of the repair section. Filter layers were placed on the shoreward side of the cap as follows (Figure 34): (a) 2-ft-thick lower layer of 3- to 6-in. stone placed above, and shoreward of, new/existing armor stone, (b) overlaid with 9 in. of 0.1- to 0.4-in. material, and (c) covered by a layer of 500- to 4,000-lb riprap stone. Total cost of the repairs was \$51,000.
